Fields Brook Action Group

October 11, 2005

DNAPL Presentation

2005 Contamination Source Identification and Delineation Study

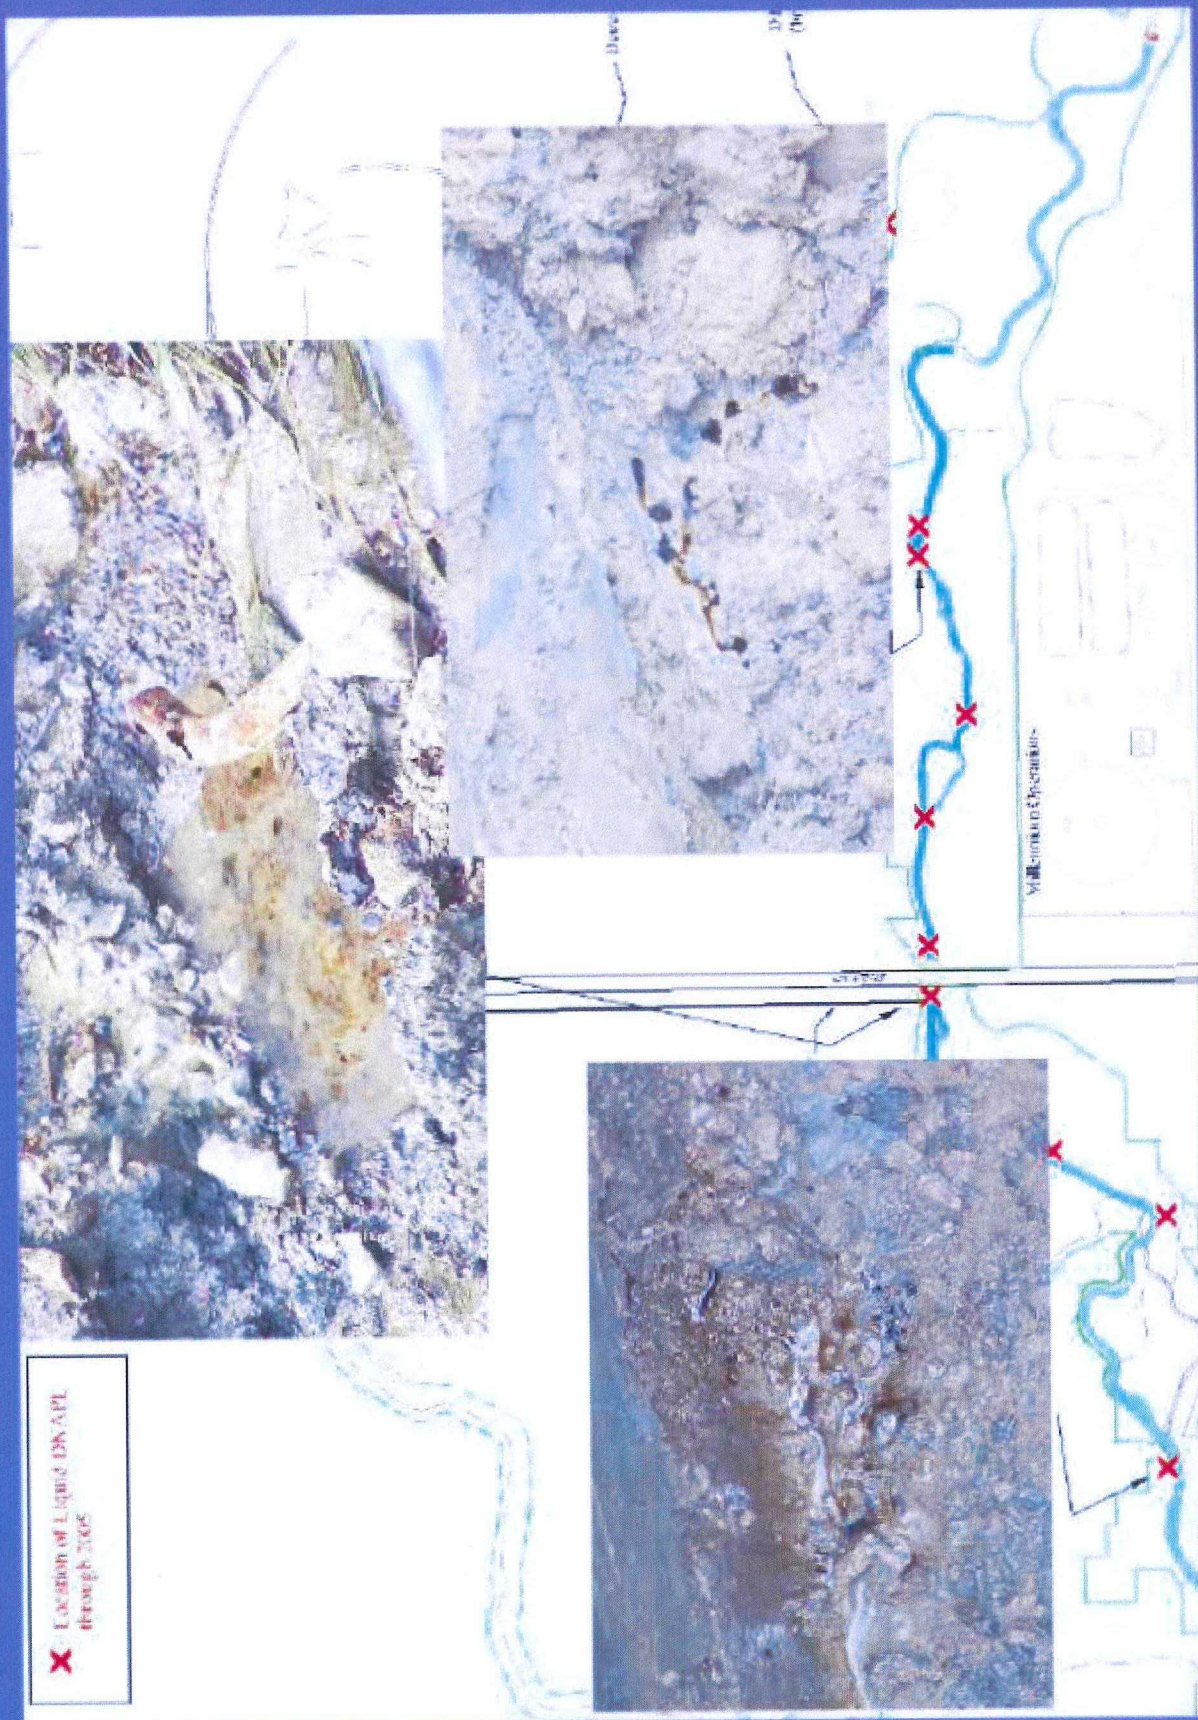
Figure 10

- Visual Observations
- Elevated PID readings

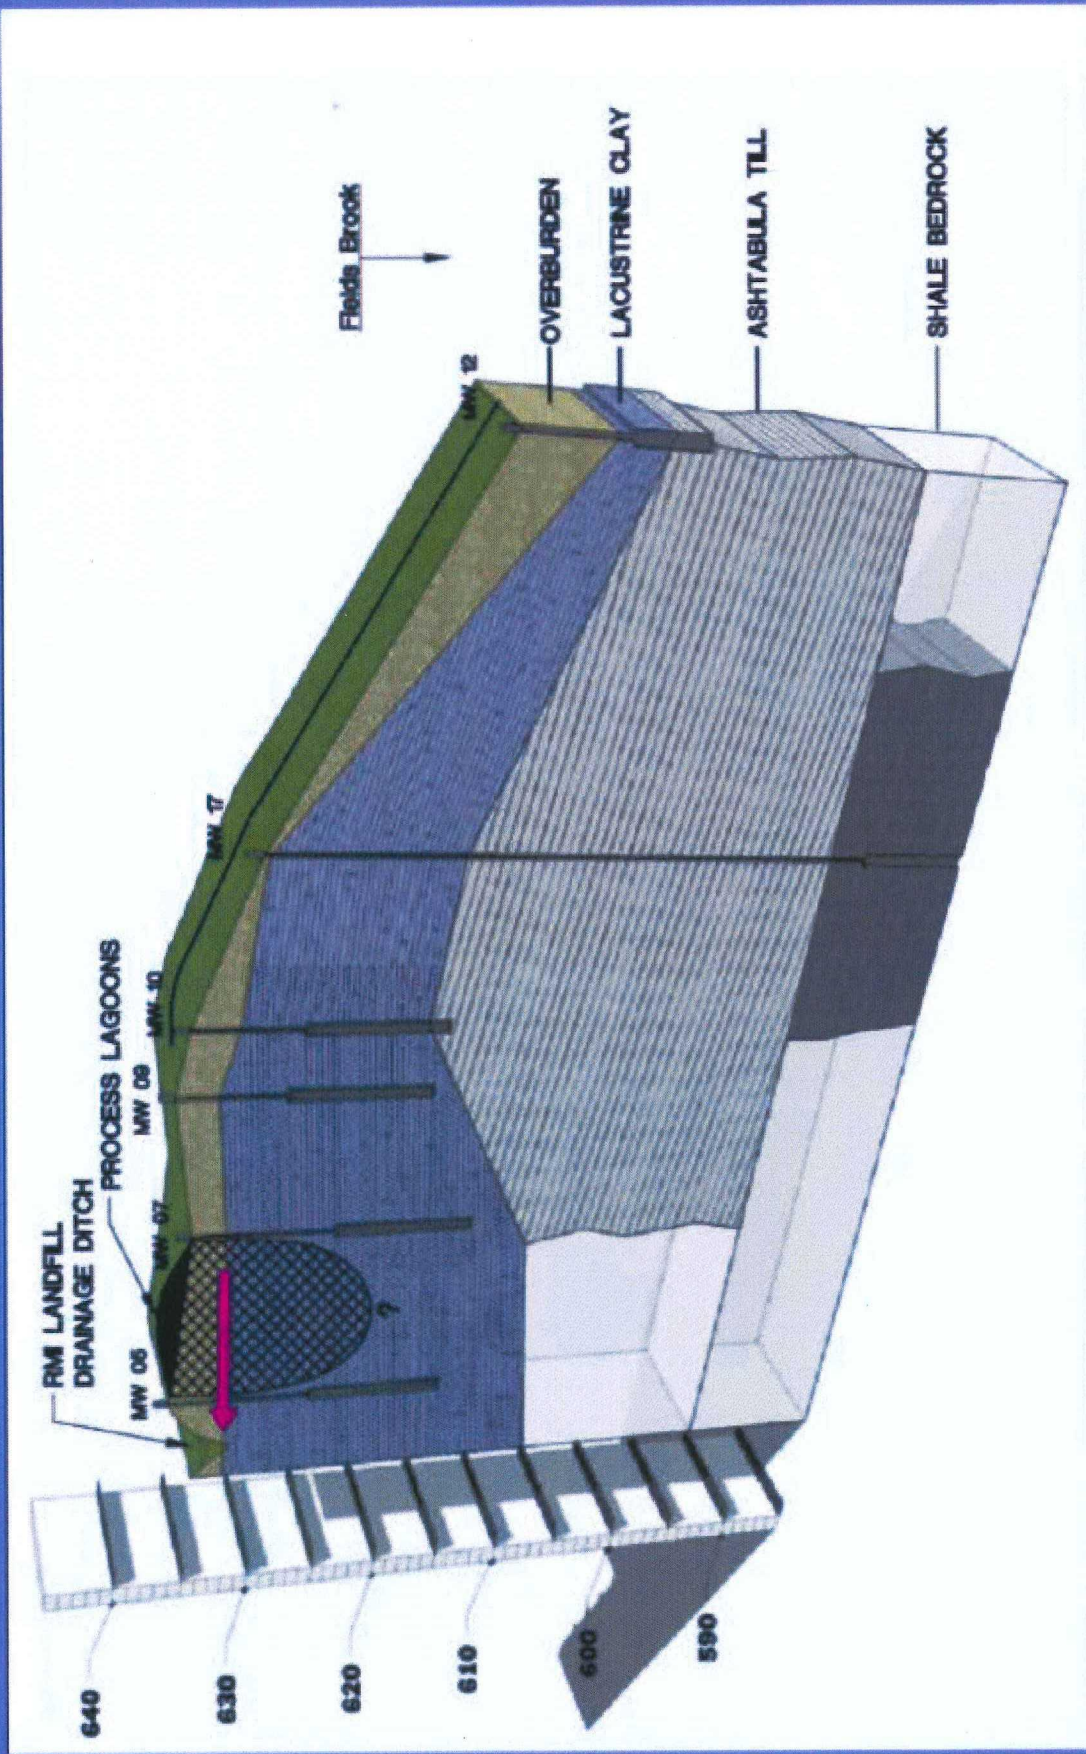
Figure 17

- Migration of DNAPL can occur at multiple elevations in the lacustrine clay
- Migration of DNAPL can occur at the lacustrine clay and till interface
